**2nd International Symposium on Building
Pathology, Durability and Rehabilitation**

The House Roof Story

Lenko Plestina

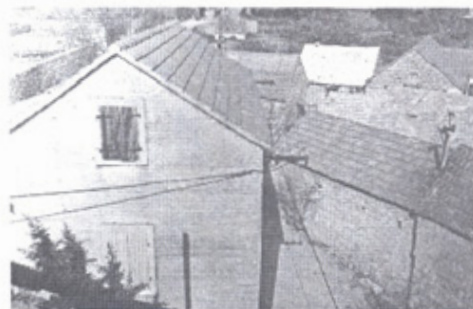
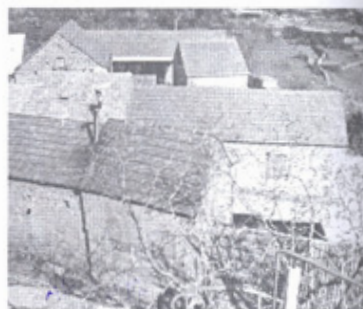
Fig. 3 – Stone and brick tile roofs in the neighborhood of house

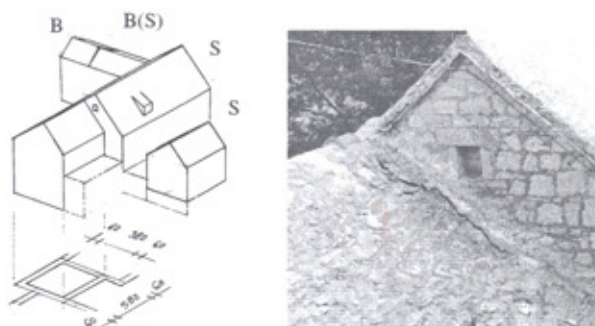
Fig. 5 – Cluster by the south side of the house - roofs: S-stone, B-tiles, B(S)-tiles (ex. stone)

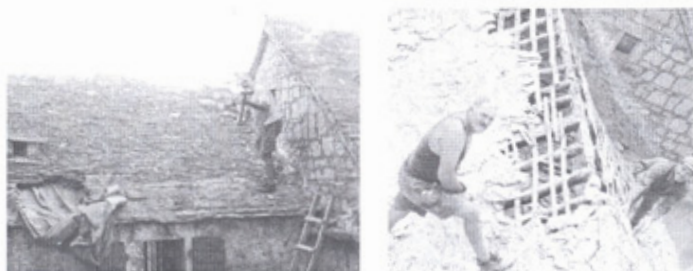
Fig. 6 – Beginning of work-taking stone tiles from the roof down

In August 1997, after St. Rocco's (local patron) Day, two laborers, the one trained for the roof work and his assistant, started working on the roof. Bigger stone tiles were saved and used later in some paving. Trash and small broken pieces were to be put later in the house foundation as a sub layer for the concrete slab, in the base of an entrance ramp, and some was put into the garden. Somehow, all material had been spread on the site.

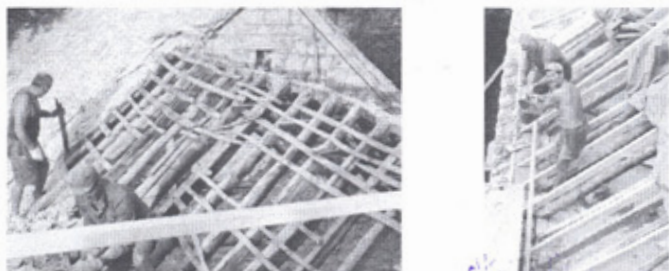
Fig. 7 – New rafters are added to the olds, new eave is reinforced by concrete

Wooden split rods were taken down. Few rafters were torn; others lost their shape a bit but could be used, however. Over, new rafters 5/8 cm were laid and connected with the old ones. New eaves are made of existing stones with concrete fixation of both old and new rafters. Laths 3/5 were put for tile sub-layers, tiles were put, and connection of roof and neighboring walls were covered with mortar.

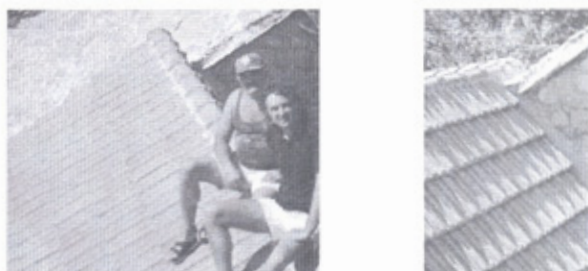
Fig. 8 – Roof is finished: it looked as a well-done job, but...!

Heavy autumn rains came and unexpected problems occurred. The beautiful roof did not resist, and some drops of water passed through. Leakage became my obsession in the following years.

The roof had a really fine slope, almost 45° , and tiles were laid very neatly, but anyway... I could not find out if the quality of tiles was bad, maybe made of porous material or the joints were poorly done. The tile manufacturer came into inspection, tried to get rid of his responsibility, and tried to buy the time. I rejected any idea of going to the court (to many nerves spending) hoping that I would find some elegant solution. I was not in a hurry because this house is a part of a bigger dwelling unit I used for vacation time only. That was the reason I did not act promptly. At one moment, the manufacturer was willing to change the tiles, but not to make new eaves and finish the connection with walls aside. Also in the time of their offer I started with my solution, and I gave up any demands towards the manufacturer.

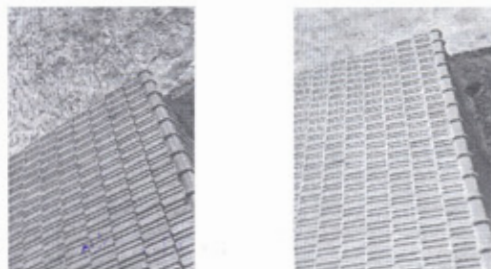
Fig. 9 – Sanative work with cement glue and mortar- from outside

I tested some left tiles on porous ness, and those were OK, but that didn't mean that all of them on the roof were good. If only some of them had been bad, the whole roof would have had the same problem, but at that time I thought that joints were not correct. Although I was warned that covering of joints was not good, without better idea at that time, I decided anyway to fill the slanted joints up with ceramic cement glue, while I left free the horizontal joints. Contrary to my expectations the problem was not solved. Then I decided to cover the joints from inside. The problem still persisted and water drops were in again.

Then I concluded, after the joints are filled with cement glue and cement mortar, that problem is the porosity of some tiles. I thought that spreading the silicon liquid over the tile would stop water from pouring in. It was made, but without any effect.

5.3 Bad attempt with cement glue and mortar

After making previous mistakes, and after the roof was not waterproof I had to take all tiles down. They were fixed with nails and it was not so difficult to get the tiles free from laths. Then one proper construction could be applied. Instead, filling the joints with cement glue and mortar, all roof surfaces became one monolithic slab, and it was almost impossible to take it down without significant ruining of the wooden construction and getting a lot of waste crash material. This mistake made me think about how to solve the problem without tearing down this failing roof.

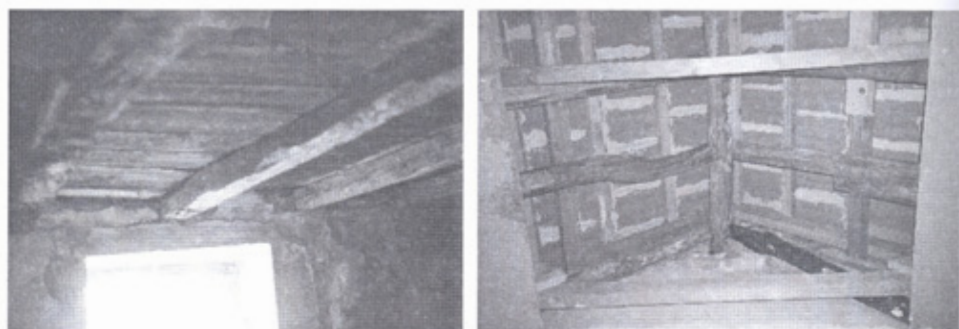
Fig. 10 – Sanative work from inside, attic board and joists are later removed

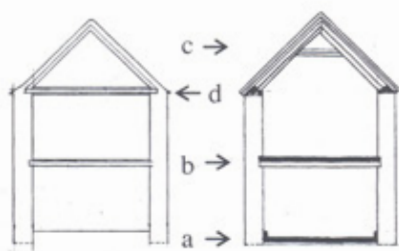
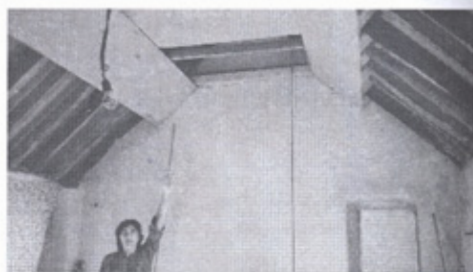
Fig. 11 – Old and new section & interior space

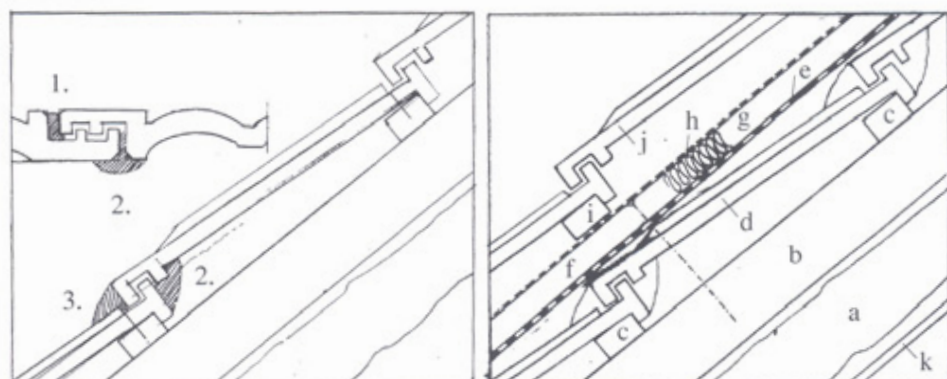
Fig. 12 – Tries to stop water in /1.2.3/ with cement glue + mortar & “roof over roof”
 a) old rafter, b) new rafter 5/8, c) lath 3/5, d) brick tile e) bitumen sheeting,
 f) counter-lath, g) thermal insulation, h) plastic foil, i) lath, j) brick tile, k) ceiling

The final decision was to put new brick tiles over the existing roof. Spatial idea of the interior was to enlarge the height of the inside space and that is why the joists of attic were removed (d). But before taking them off, the construction had been reinforced with concrete slab on the soil among the foundations (a), with reinforced slab between the ground and first floor (b) and with partial upper connections of rafters (c) – see fig.11. Previous stone tile load over the wooden construction was about 200 kg/m². New tile load was about 70 kg/m². It meant that new reinforced construction had quite a spare strength for new loads. They are: first, tar insulation sheet all over the roof, then laths 3/5 cm and counter laths 3/5 cm for new tiles. In between laths thermal insulation was laid and protected with vinyl foil. The problem how to fix new laths for the existing roof was solved with 20cm long nails. Holes were drilled on the positions of rafters underneath and nails were easily inserted. Two workers made this job in four days in February 2001. Almost three and a half year after the first beginning. (Luckily, I did not need this space badly, so I could take time to think about it and search the best solution).

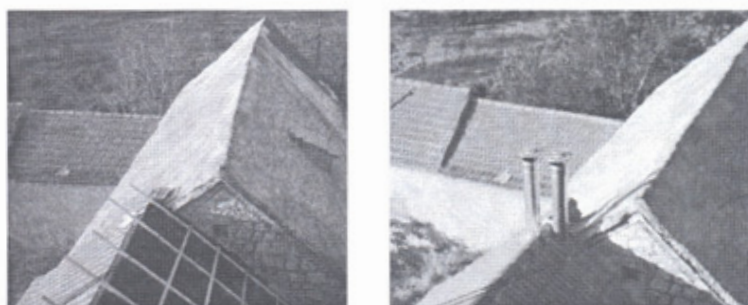
Fig. 13 – Bitumen sheeting with laths - later penetration of two chimney tubes (protected with 2 mm lead sheet, and so far it works perfectly)

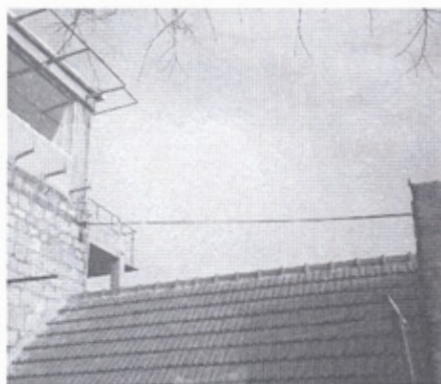
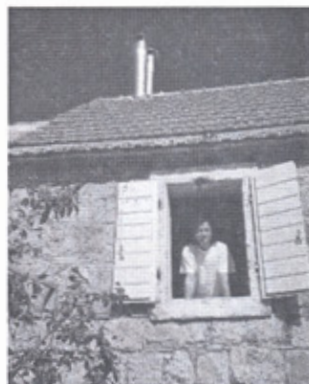
Fig. 14 – The repair of the roof is finally done in proper way
